Typical NNG-NAV Kit issues and known fixes

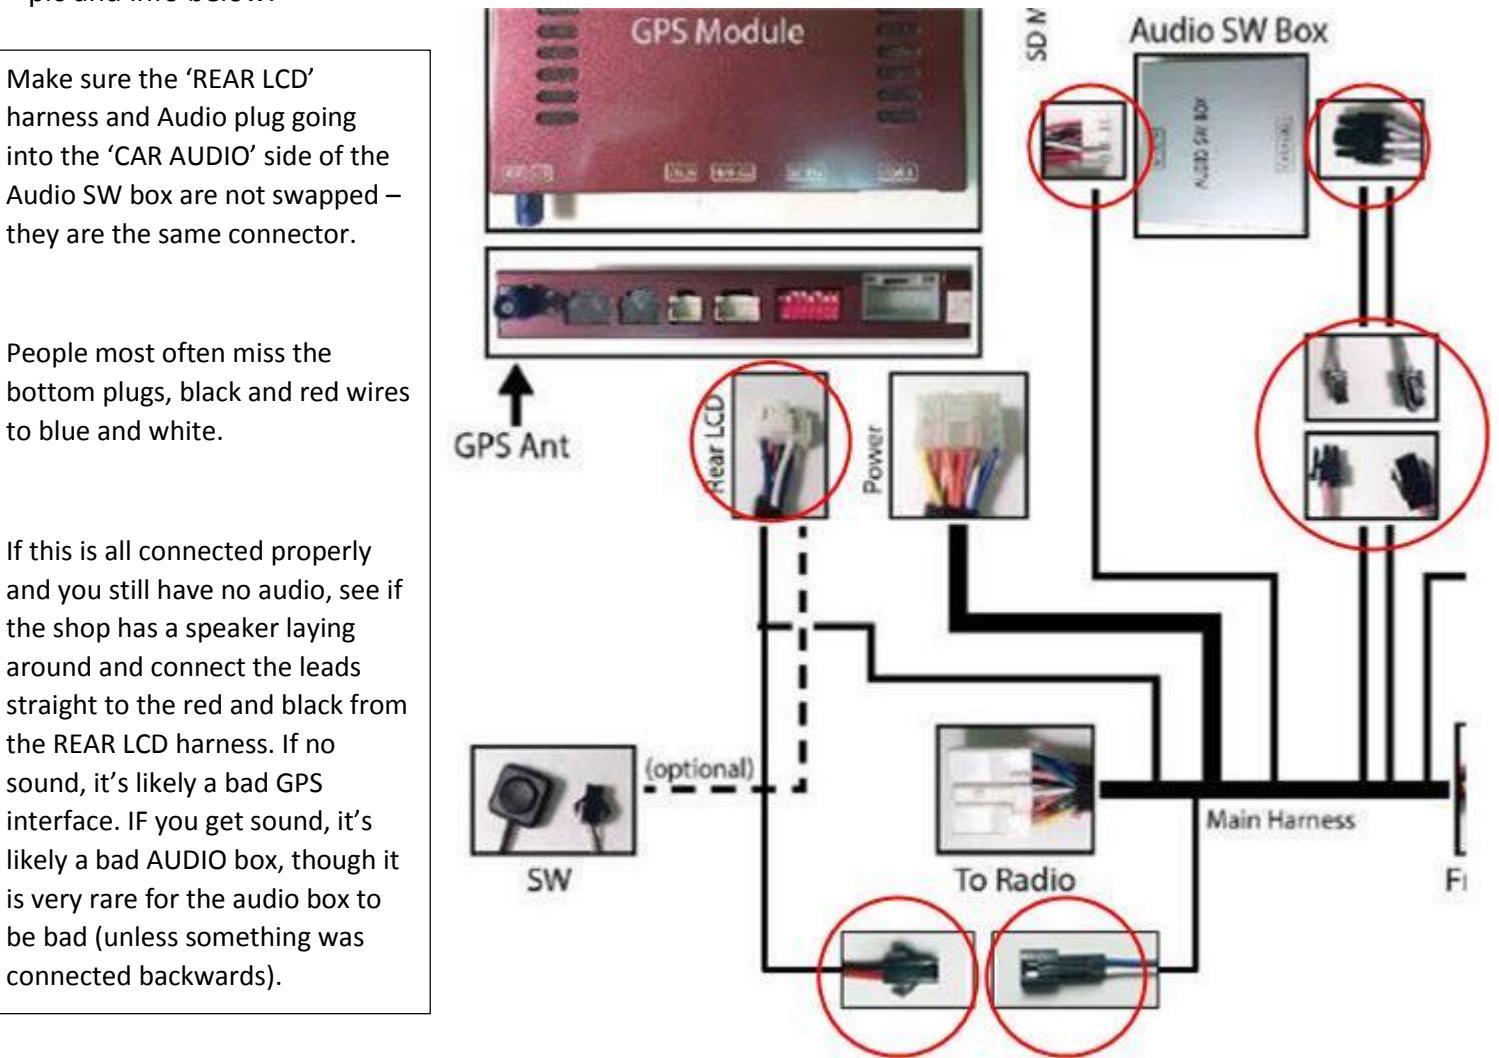
Check: Seen usually in Toyota kits, when portions of the audio connections are not connected. With regard to the Audio Switching box, 7 connections need to be made (for Toyota) for sound to be heard. This issue should not be related to an amplified system as the amplified JBL system will typically have Navigation already. See pic and info below:

they are the same connector. People most often miss the bottom plugs, black and red wires

Make sure the 'REAR LCD' harness and Audio plug going

to blue and white.

If this is all connected properly and you still have no audio, see if the shop has a speaker laying around and connect the leads straight to the red and black from the REAR LCD harness. If no sound, it's likely a bad GPS interface. IF you get sound, it's likely a bad AUDIO box, though it is very rare for the audio box to be bad (unless something was connected backwards).

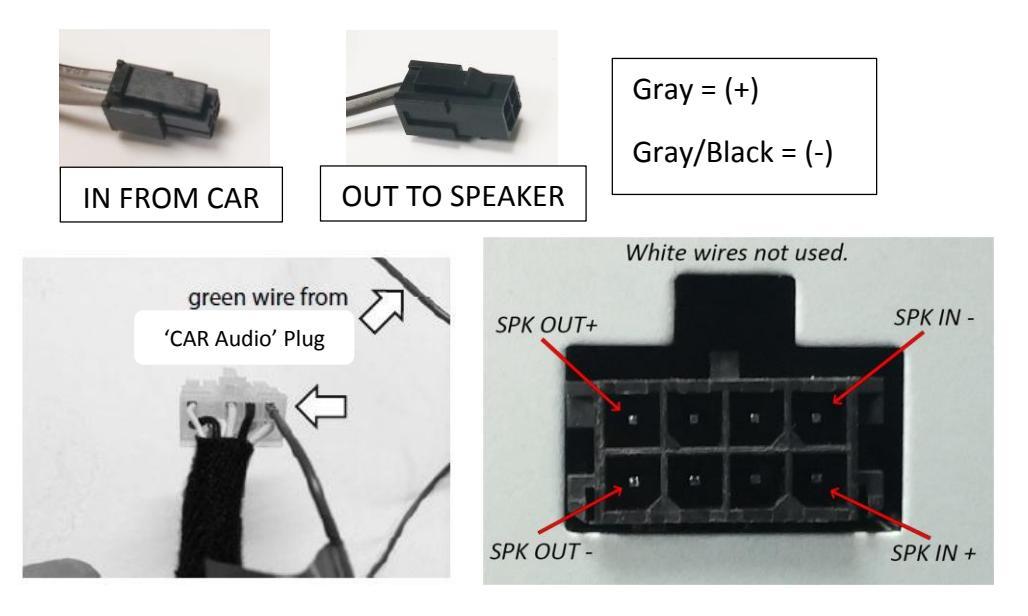
Issue: No labels on IN vs OUT from Audio Switch Module, or NO center channel speaker exists.

From the black audio Y-Adapter that connects here, the *female* side is *out to speaker*, and the *male* side is *in from car*.

Note: The **GREEN** 'MUTE' wire MUST also be pinned into the MAIN power harness connector (top right) in order for muting and audio switching to work at all. Do not forget to connect the **Audio signal** from the REAR-LCD harness. See the diagram in the latest manual.

Fix: Similar to our NTX-54 Nissan kit where you must cut open the signal leads to the center channel speaker (if equipped). Below is a pinout for the Audio Switching box. *IF NO CENTER CHANNEL,* installer must locate the front left speaker leads that head into the door. These wires are *typically White and White/Brown* for front left. The latest FORD manual outlines all of this and can be found on the google drive or the website.

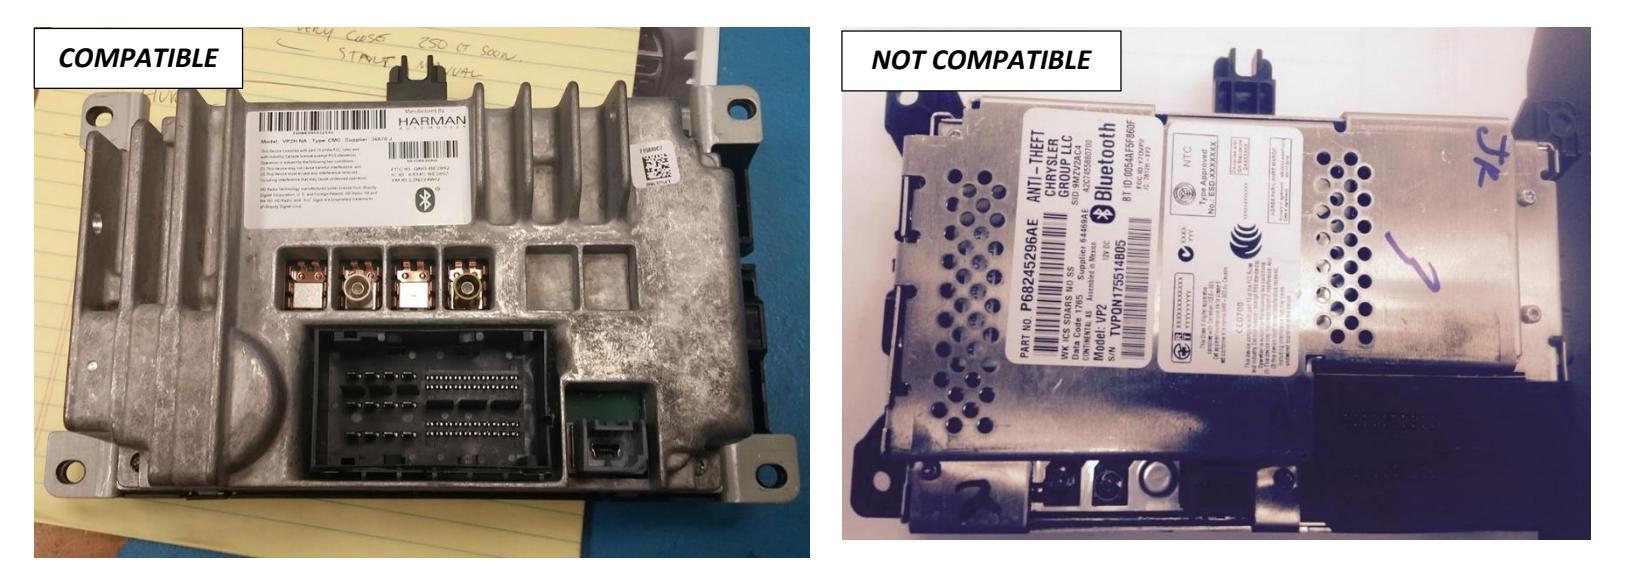
Issue: Jeep GC modification board ribbons will not line up.

Fix: This was covered in an earlier email, but to reiterate, there are 2 types of 5" RA2 radios in Jeep Grand Cherokees. One is made by HARMAN and has heat-sinks, the other has *NO HARMAN* logo and no heat-sinks. See below for radio differences:
